PASSAIC RIVER BASIN

MIDVALE DAM

PHASE I INSPECTION REPORT NATIONAL DAM SAFETY PROGRAM

JUNE 1978

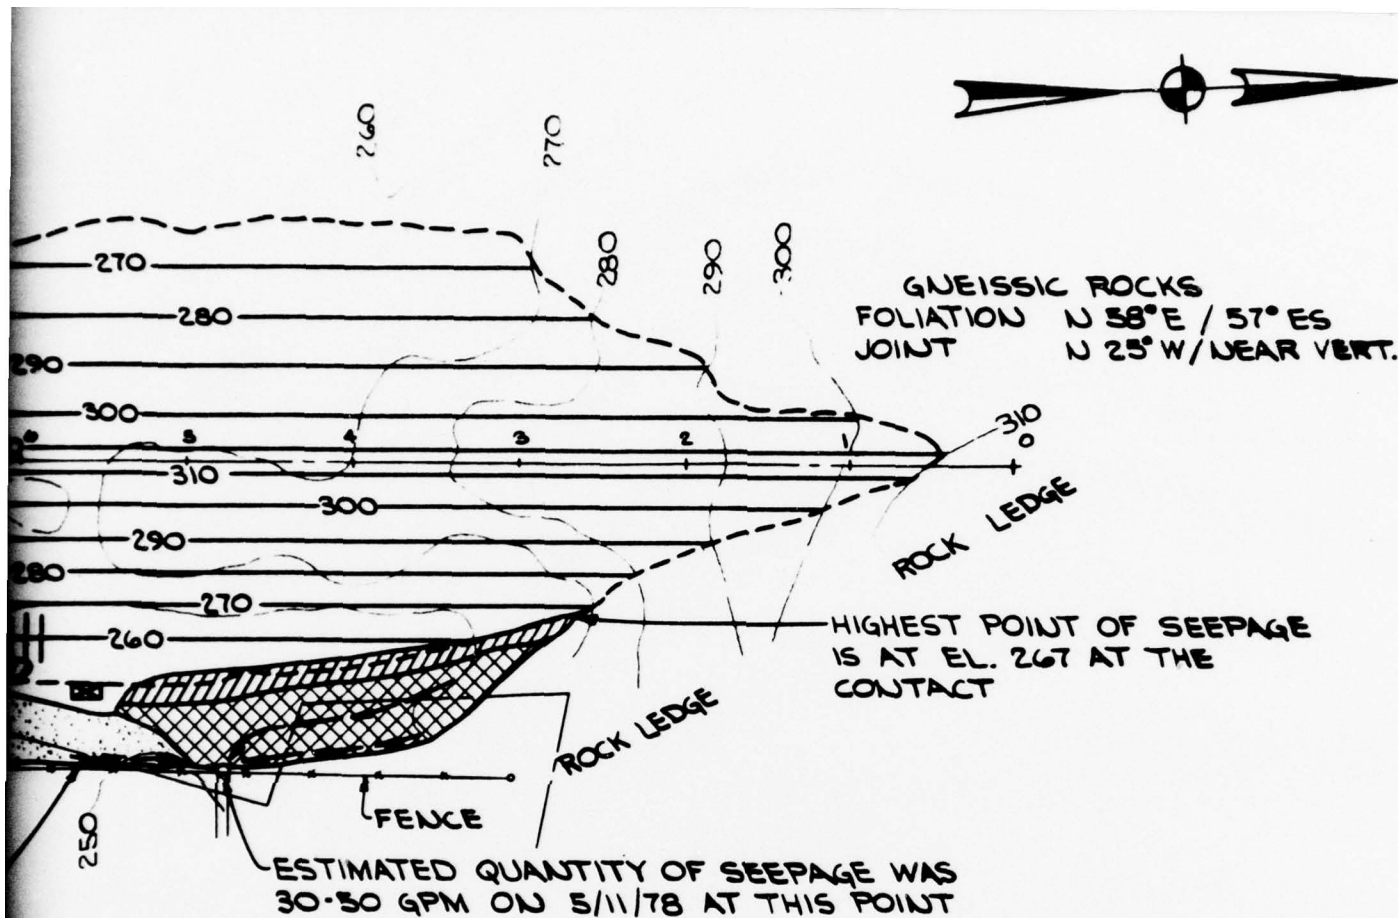
FIGURE 3
PLAN VIEW
MIDVALE DAM
SEEPAGE AREAS
NOT TO SCALE

6.1.1 Visual Observations: Seepage emanates from the toe and left abutment areas, as discussed in Section 3.1.2. The seepage apparently is not indicative of a present instability but must be assumed to pose a threat to the future integrity of the dam by possible piping and/or erosion. This threat must be assumed because adequate assessment cannot be made due to the lack of detailed information on the composition of the dam and flow characteristics through the dam and foundation.

SLIGHT SLOUGHING OF SURFICIAL SOILS

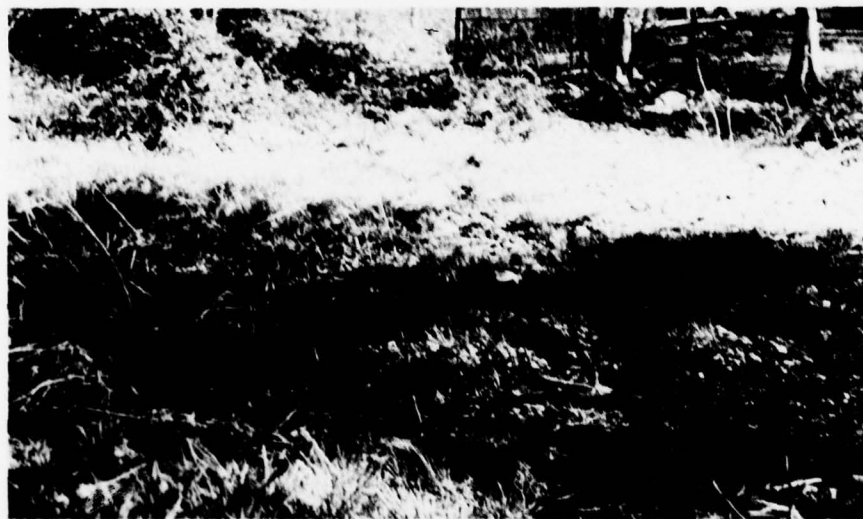
VIEW OF TOE AREA. NOTE WATER IN FOREGROUND

7.2.3 Operational/Maintenance Procedures: The seepage should be observed frequently for cloudy or muddy flows which would indicate internal erosion (piping). Such a condition would be indicative of a rapidly deteriorating dam, and should be regarded as a potential threat to safety.

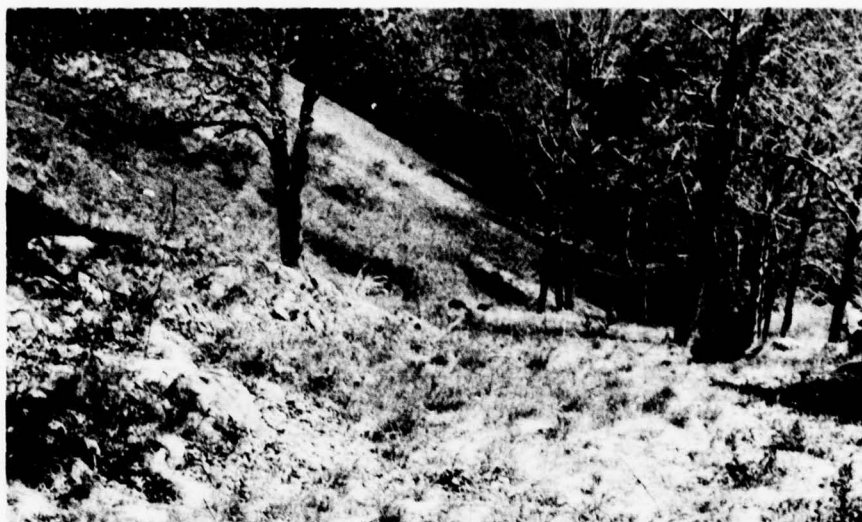
VIEW FROM UPPER RIGHT ABUTMENT
